FIRED FURNACE INSPECTIONS

MEASURE FURNACE TUBE METAL TEMPERATURES THROUGH A GAS FLAME WITH THERMAL IMAGING

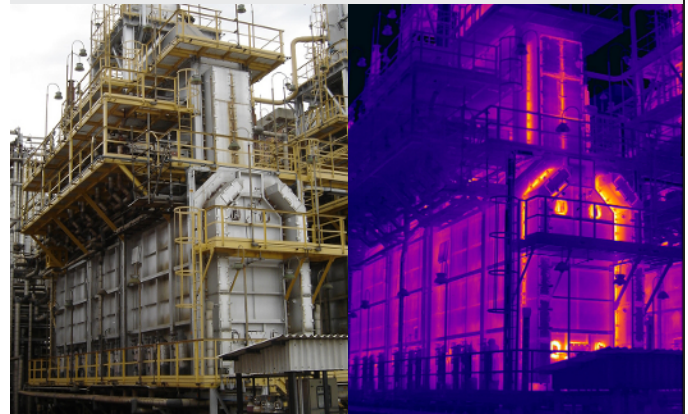
Thermal imaging of the external surface of the firebox shell and flue ducts can identify areas of overheating due to internal refractory damage.

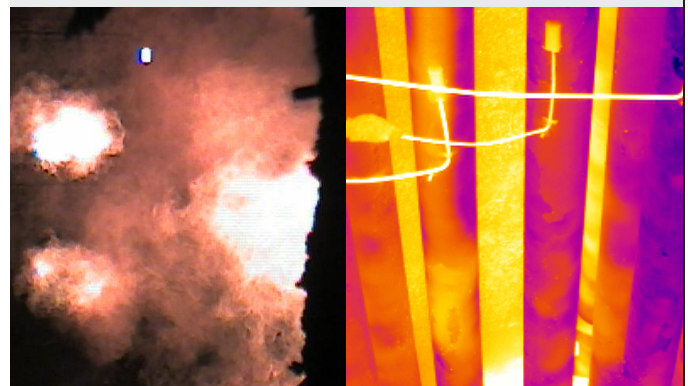
The GF309 makes it possible to monitor furnace tubes for signs of overheating, and to accurately measure the tube metal temperature, even when viewing the tubes directly through the gas flames.

Thermal imaging is a powerful technology that enables furnace inspectors to evaluate the condition of the firebox, burners, and tubes, even when looking directly through gas flames. The GF309 is designed to remove the flame from the image, allowing the inspector to monitor the tubes for any signs of overheating or damage. Thermocouples are notorious for failure inside a furnace and often give inaccurate temperature readings, which could affect the reliability of the furnace. The GF309 allows the user to verify thermocouple measurements and to also see potential overheating in areas adjacent to, or away from thermocouple coverage. The FLIR GF309 also features a detachable heat shield designed to reflect heat away from the camera and camera operator, providing increased protection. There are times when the inspector only needs to view the external "shell" of the firebox and flue ducting. For this application, a premium handheld thermal camera with high temperature calibration, such as the FLIR T840, is an ideal solution.
